## Reinspection Survey

Site: Hadlow Down Village HALL, Hall Lane, Hadlow Down, TN22 4HQ  
Client: Hadlow Down Village Hall  
Report No: J032346  
Survey Date: 6th June 2025  
Report Date: 6th June 2025  
Surveyors: Martin Lisher  
Report Produced By:

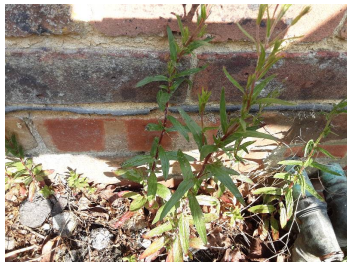
| Sample ID | Building | Floor | Description | Room/Position | Extent (m2) | Fixing | Substrate | Asbestos Type Identified | <br>Picture 13 |
|---|---|---|---|---|---|---|---|---|---|
| SH002797* | Hadlow Down Village Hall | External | Bitumen Products | External elements, Damp Proof Course | 72lm | Bonded | Brick | Chrysotile | |

| Sample ID | Building | Floor | Description | Room/Position | Extent (m2) | Fixing | Substrate | Asbestos Type Identified | <br>Picture 13 |
|---|---|---|---|---|---|---|---|---|---|
| Low risk ACM (Bound in matrix). Where appropriate label with warning signs. Undertake routine inspections for damage and deterioration. Work on this material does not require a license. Work on this material may be notifiable to the appropriate enforcing authority. Disposal of asbestos waste by a licensed contractor only. All work must conform to the 'Control of Asbestos Regulations 2012'. | | | | | 2 | 2 | 4 | Very Low | |

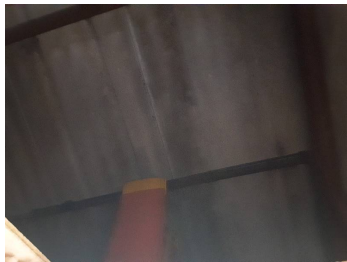
| Sample ID | Building | Floor | Description | Room/Position | Extent (m2) | Fixing | Substrate | Asbestos Type Identified | <br>Picture 2 |
|---|---|---|---|---|---|---|---|---|---|
| As SH002794* | Hadlow Down Village Hall | Ground Floor | Cement | Committee room, Above suspended ceiling | 27m <sup>2</sup> | Bolted | Metal | Chrysotile | |

| Sample ID | Building | Floor | Description | Room/Position | Extent (m2) | Fixing | Substrate | Asbestos Type Identified | <br>Picture 2 |
|---|---|---|---|---|---|---|---|---|---|
| Low risk ACM (bound in matrix) remove, repair or encapsulate under controlled conditions. Work on this material does not require a license. Work on this material may be notifiable to the appropriate enforcing authority. Disposal of asbestos waste by a licensed contractor only. All work must conform to the 'Control of Asbestos Regulations 2012'. | | | | | 3 | 5 | 8 | Very Low | |

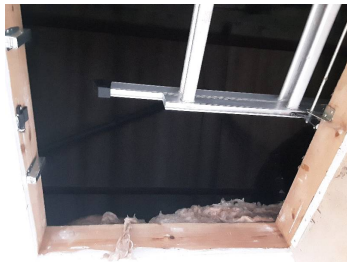
| Sample ID | Building | Floor | Description | Room/Position | Extent (m2) | Fixing | Substrate | Asbestos Type Identified | <br>Picture 3 |
|---|---|---|---|---|---|---|---|---|---|
| As SH002794* | Hadlow Down Village Hall | Ground Floor | Cement | Lobby, Above suspended ceiling | 36m <sup>2</sup> | Bolted | Metal | Chrysotile | |

| Sample ID | Building | Floor | Description | Room/Position | Extent (m2) | Fixing | Substrate | Asbestos Type Identified | <br>Picture 3 |
|---|---|---|---|---|---|---|---|---|---|
| Low risk ACM (bound in matrix) remove, repair or encapsulate under controlled conditions. Work on this material does not require a license. Work on this material may be notifiable to the appropriate enforcing authority. Disposal of asbestos waste by a licensed contractor only. All work must conform to the 'Control of Asbestos Regulations 2012'. | | | | | 3 | 5 | 8 | Very Low | |

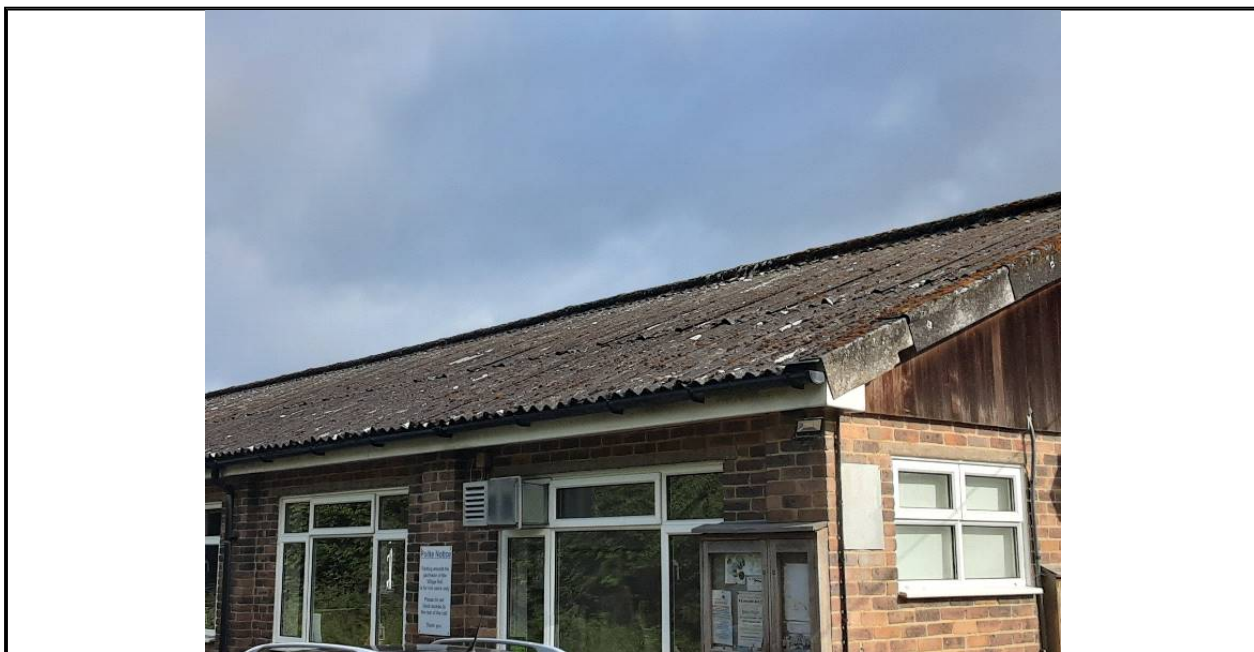
| Item No | Sample ID | Building | Floor | Room No | Room Description | Location | Extent in m2 | Substrate | Product type | Condition | Surface treatment | Asbestos type | Accessibility | Total risk assessment score | Risk category |
|---|---|---|---|---|---|---|---|---|---|---|---|---|---|---|---|
| 11 | SH002795* | Hadlow Down Village Hall | External | 1 | External elements | Corrugated Roof Sheets - Cement | 243m <sup>2</sup> | Bolted, Metal | (1) Asbestos Cement | Medium Damage | 1 | Chrysotile | (0) Usually inaccessible or unlikely to be disturbed | 7 | Very Low |

| Sample No: | SH002795* |

| Recommended Action: | Low risk ACM (bound in matrix) remove, repair or encapsulate under controlled conditions. Work on this material does not require a license. Work on this material may be notifiable to the appropriate enforcing authority. Disposal of asbestos waste by a licensed contractor only. All work must conform to the 'Control of Asbestos Regulations 2012'. |

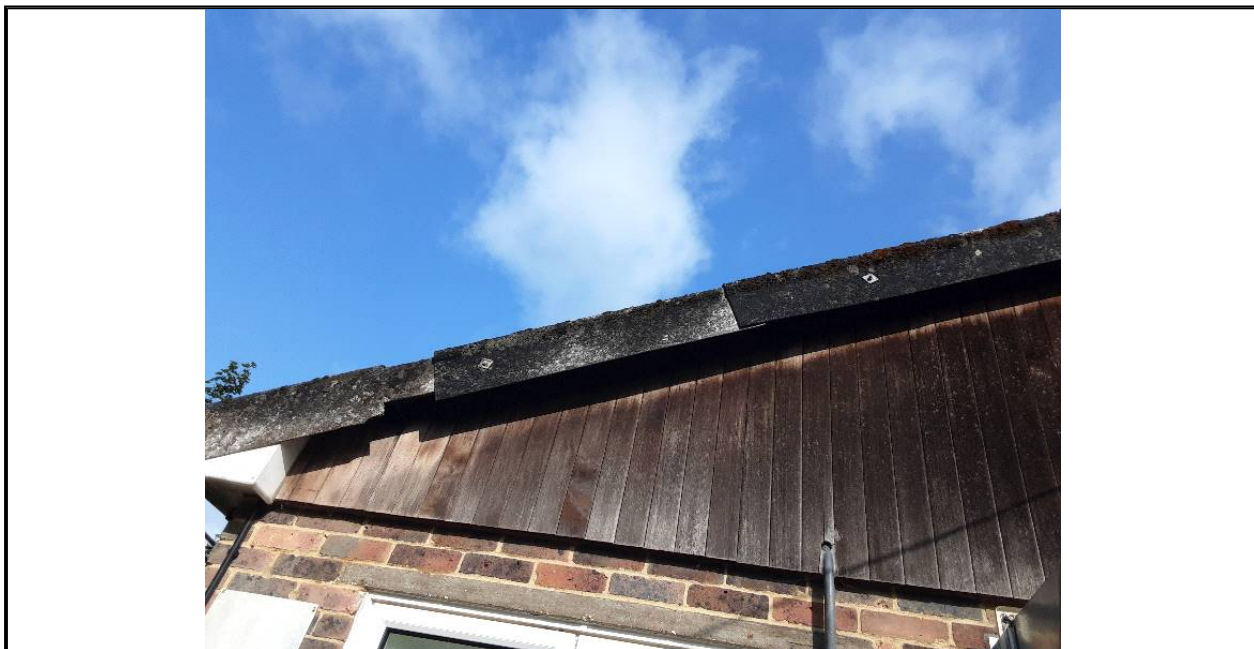
| Item No | Sample ID | Building | Floor | Room No | Room Description | Location | Extent in m2 | Substrate | Product type | Condition | Surface treatment | Asbestos type | Accessibility | Total risk assessment score | Risk category |
|---|---|---|---|---|---|---|---|---|---|---|---|---|---|---|---|
| 12 | SH002796* | Hadlow Down Village Hall | External | 1 | External elements | Barge board - Cement | 20lm | Bolted, Metal | (1) Asbestos Cement | Medium Damage | 1 | Chrysotile | (0) Usually inaccessible or unlikely to be disturbed | 7 | Very Low |

| Sample No: | SH002796* |

| Recommended Action: | Low risk ACM (bound in matrix) remove, repair or encapsulate under controlled conditions. Work on this material does not require a license. Work on this material may be notifiable to the appropriate enforcing authority. Disposal of asbestos waste by a licensed contractor only. All work must conform to the 'Control of Asbestos Regulations 2012'. |

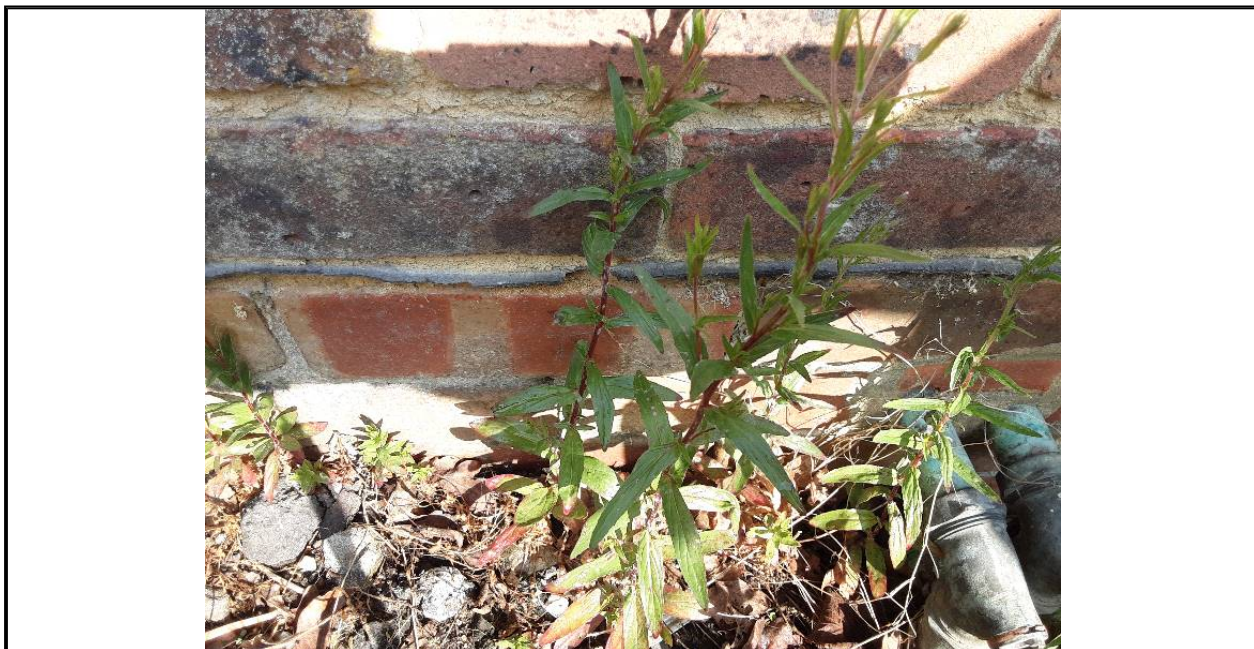
| Item No | Sample ID | Building | Floor | Room No | Room Description | Location | Extent in m2 | Substrate | Product type | Condition | Surface treatment | Asbestos type | Accessibility | Total risk assessment score | Risk category |
|---|---|---|---|---|---|---|---|---|---|---|---|---|---|---|---|
| 13 | SH002797* | Hadlow Down Village Hall | External | 1 | External elements | Damp Proof Course - Bitumen Products | 72lm | Bonded, Brick | (1) Well Bound Material | Good Condition | 0 | Chrysotile | (0) Usually inaccessible or unlikely to be disturbed | 4 | Very Low |

| Sample No: | SH002797* |

| Recommended Action: | Low risk ACM (Bound in matrix). Where appropriate label with warning signs. Undertake routine inspections for damage and deterioration. Work on this material does not require a license. Work on this material may be notifiable to the appropriate enforcing authority. Disposal of asbestos waste by a licensed contractor only. All work must conform to the 'Control of Asbestos Regulations 2012'. |

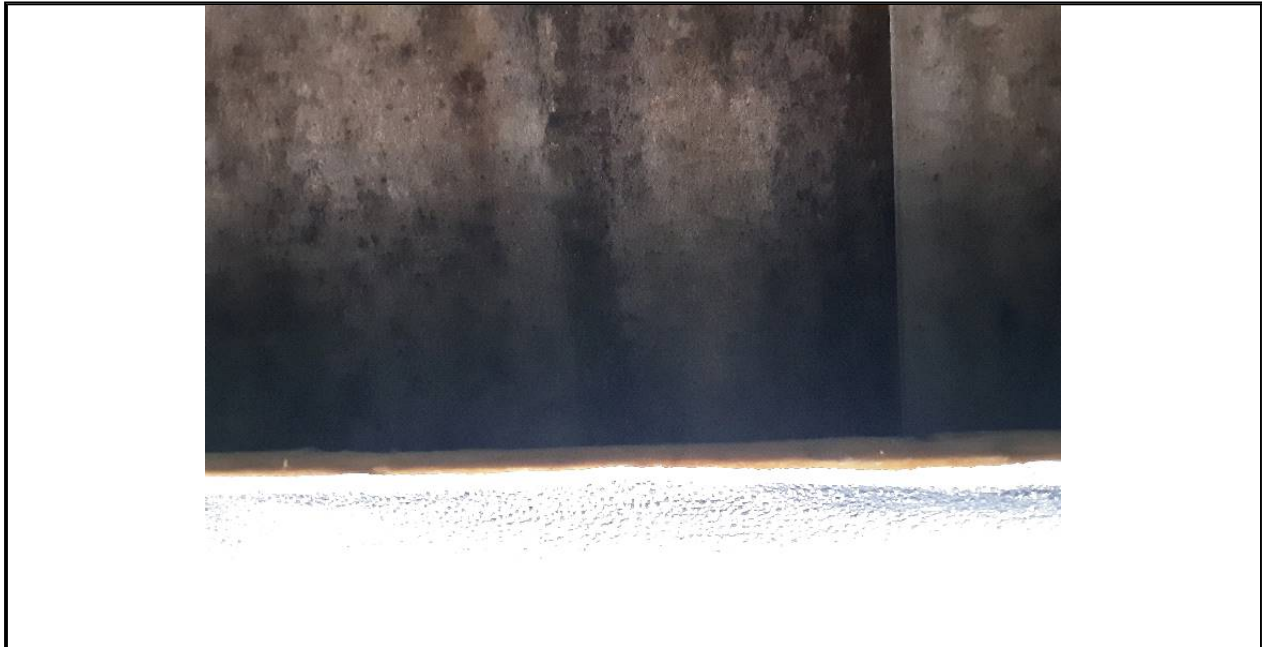
| Item No | Sample ID | Building | Floor | Room No | Room Description | Location | Extent in m2 | Substrate | Product type | Condition | Surface treatment | Asbestos type | Accessibility | Total risk assessment score | Risk category |
|---|---|---|---|---|---|---|---|---|---|---|---|---|---|---|---|
| 1 | SH002794* | Hadlow Down Village Hall | Ground Floor | 1 | Main hall and stage | Above suspended ceiling - Cement | 180m <sup>2</sup> | Bolted, Metal | (1) Asbestos Cement | Good Condition | 1 | Chrysotile | (0) Usually inaccessible or unlikely to be disturbed | 8 | Very Low |

| Sample No: | SH002794* |

| Recommended Action: | Low risk ACM (bound in matrix) remove, repair or encapsulate under controlled conditions. Work on this material does not require a license. Work on this material may be notifiable to the appropriate enforcing authority. Disposal of asbestos waste by a licensed contractor only. All work must conform to the 'Control of Asbestos Regulations 2012'. |

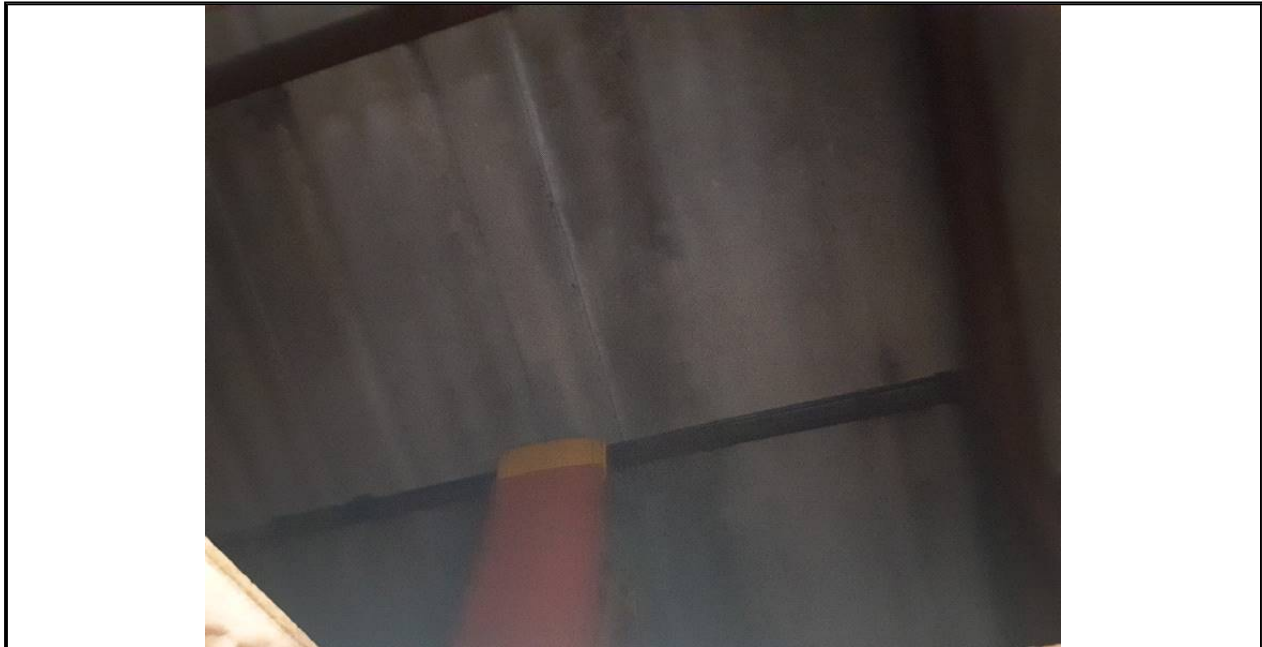
| Item No | Sample ID | Building | Floor | Room No | Room Description | Location | Extent in m2 | Substrate | Product type | Condition | Surface treatment | Asbestos type | Accessibility | Total risk assessment score | Risk category |
|---|---|---|---|---|---|---|---|---|---|---|---|---|---|---|---|
| 2 | As SH002794* | Hadlow Down Village Hall | Ground Floor | 2 | Commitee room | Above suspended ceiling - Cement | 27m <sup>2</sup> | Bolted, Metal | (1) Asbestos Cement | Good Condition | 1 | Chrysotile | (0) Usually inaccessible or unlikely to be disturbed | 8 | Very Low |

| Sample No: | As SH002794* |

| Recommended Action: | Low risk ACM (bound in matrix) remove, repair or encapsulate under controlled conditions. Work on this material does not require a license. Work on this material may be notifiable to the appropriate enforcing authority. Disposal of asbestos waste by a licensed contractor only. All work must conform to the 'Control of Asbestos Regulations 2012'. |

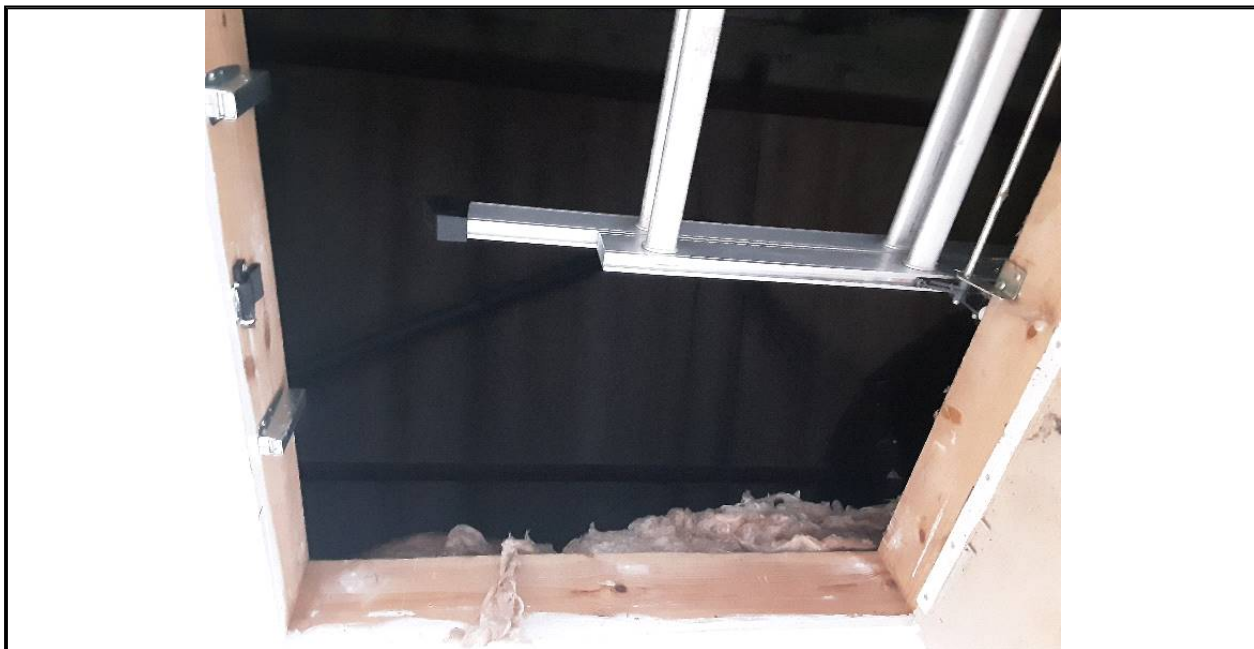
| Item No | Sample ID | Building | Floor | Room No | Room Description | Location | Extent in m2 | Substrate | Product type | Condition | Surface treatment | Asbestos type | Accessibility | Total risk assessment score | Risk category |
|---|---|---|---|---|---|---|---|---|---|---|---|---|---|---|---|
| 3 | As SH002794* | Hadlow Down Village Hall | Ground Floor | 3 | Lobby | Above suspended ceiling - Cement | 36m <sup>2</sup> | Bolted, Metal | (1) Asbestos Cement | Good Condition | 1 | Chrysotile | (0) Usually inaccessible or unlikely to be disturbed | 8 | Very Low |

| Sample No: | As SH002794* |

| Recommended Action: | Low risk ACM (bound in matrix) remove, repair or encapsulate under controlled conditions. Work on this material does not require a license. Work on this material may be notifiable to the appropriate enforcing authority. Disposal of asbestos waste by a licensed contractor only. All work must conform to the 'Control of Asbestos Regulations 2012'. |
