Management Survey

Site: Hadlow Down Village HALL, Hall Lane, Hadlow Down, TN22 4HQ
UPRN: N/A
Client: Hadlow Down Village Hall
Report No: J024575
Survey Date: 24th February 2023
Report Date: 24th February 2023
Surveyors: Martin Lisher

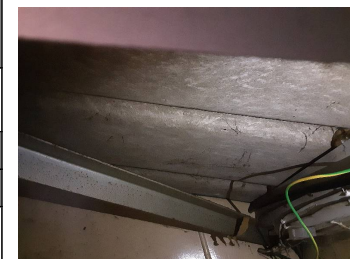
Picture 1

Sample ID	Building	Floor	Description	Room/Position	Extent (m2)	Fixing	Substrate	Asbestos Type Identified
SH002794	Hadlow Down Village Hall	Ground Floor	Cement	Main hall and stage, Above suspended ceiling	180m ²	Bolted	Metal	Chrysotile
Recommendations					Assessment Scores			Risk Code
					Material	Priority	Total	
Low risk ACM (bound in matrix) remove, repair or encapsulate under controlled conditions. Work on this material does not require a license. Work on this material may be notifiable to the appropriate enforcing authority. Disposal of asbestos waste by a licensed contractor only. All work must conform to the 'Control of Asbestos Regulations 2012'.					3	5	8	Very Low
Reinspection Due		12 months	Actions Taken	N/A	Time Scale			Action Completed Sign & Date

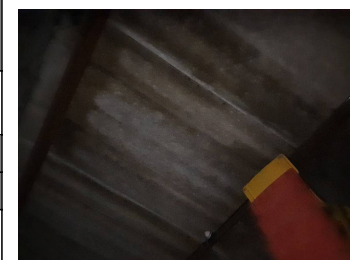
Picture 2

Sample ID	Building	Floor	Description	Room/Position	Extent (m2)	Fixing	Substrate	Asbestos Type Identified
As SH002794	Hadlow Down Village Hall	Ground Floor	Cement	Committee room, Above suspended ceiling	27m ²	Bolted	Metal	Chrysotile
Recommendations					Assessment Scores			Risk Code
					Material	Priority	Total	
Low risk ACM (bound in matrix) remove, repair or encapsulate under controlled conditions. Work on this material does not require a license. Work on this material may be notifiable to the appropriate enforcing authority. Disposal of asbestos waste by a licensed contractor only. All work must conform to the 'Control of Asbestos Regulations 2012'.					3	5	8	Very Low
Reinspection Due		12 months	Actions Taken	N/A	Time Scale			Action Completed Sign & Date

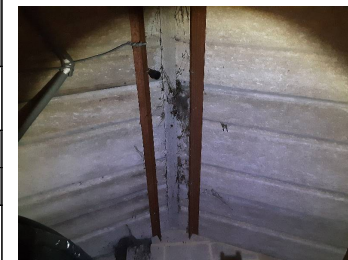
Picture 3

Sample ID	Building	Floor	Description	Room/Position	Extent (m2)	Fixing	Substrate	Asbestos Type Identified
As SH002794	Hadlow Down Village Hall	Ground Floor	Cement	Lobby, Above suspended ceiling	36m ²	Bolted	Metal	Chrysotile
Recommendations					Assessment Scores			Risk Code
					Material	Priority	Total	
Low risk ACM (bound in matrix) remove, repair or encapsulate under controlled conditions. Work on this material does not require a license. Work on this material may be notifiable to the appropriate enforcing authority. Disposal of asbestos waste by a licensed contractor only. All work must conform to the 'Control of Asbestos Regulations 2012'.					3	5	8	Very Low
Reinspection Due		12 months	Actions Taken	N/A	Time Scale			Action Completed Sign & Date

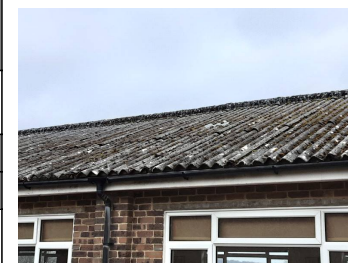
Picture 11

Sample ID	Building	Floor	Description	Room/Position	Extent (m2)	Fixing	Substrate	Asbestos Type Identified
SH002795	Hadlow Down Village Hall	External	Cement	External elements, Corrugated Roof Sheets	243m ²	Bolted	Metal	Chrysotile
Recommendations					Assessment Scores			Risk Code
					Material	Priority	Total	
Low risk ACM (bound in matrix) remove, repair or encapsulate under controlled conditions. Work on this material does not require a license. Work on this material may be notifiable to the appropriate enforcing authority. Disposal of asbestos waste by a licensed contractor only. All work must conform to the 'Control of Asbestos Regulations 2012'.					5	2	7	Very Low
Reinspection Due		12 months	Actions Taken	N/A	Time Scale			Action Completed Sign & Date

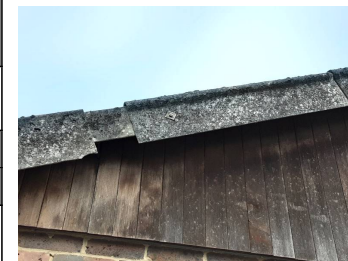
Picture 12

Sample ID	Building	Floor	Description	Room/Position	Extent (m2)	Fixing	Substrate	Asbestos Type Identified
SH002796	Hadlow Down Village Hall	External	Cement	External elements, Barge board	20lm	Bolted	Metal	Chrysotile
Recommendations					Assessment Scores			Risk Code
					Material	Priority	Total	
Low risk ACM (bound in matrix) remove, repair or encapsulate under controlled conditions. Work on this material does not require a license. Work on this material may be notifiable to the appropriate enforcing authority. Disposal of asbestos waste by a licensed contractor only. All work must conform to the 'Control of Asbestos Regulations 2012'.					5	2	7	Very Low
Reinspection Due		12 months	Actions Taken	N/A	Time Scale			Action Completed Sign & Date

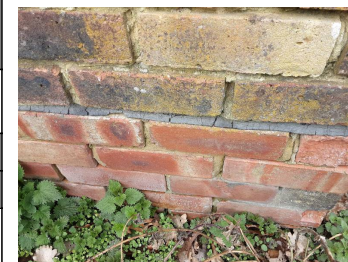
Picture 13

Sample ID	Building	Floor	Description	Room/Position	Extent (m2)	Fixing	Substrate	Asbestos Type Identified
SH002797	Hadlow Down Village Hall	External	Bitumen Products	External elements, Damp Proof Course	72lm	Bonded	Brick	Chrysotile
Recommendations					Assessment Scores			Risk Code
					Material	Priority	Total	
Low risk ACM (Bound in matrix). Where appropriate label with warning signs. Undertake routine inspections for damage and deterioration. Work on this material does not require a license. Work on this material may be notifiable to the appropriate enforcing authority. Disposal of asbestos waste by a licensed contractor only. All work must conform to the 'Control of Asbestos Regulations 2012'.					2	2	4	Very Low
Reinspection Due		12 months	Actions Taken	N/A	Time Scale			Action Completed Sign & Date

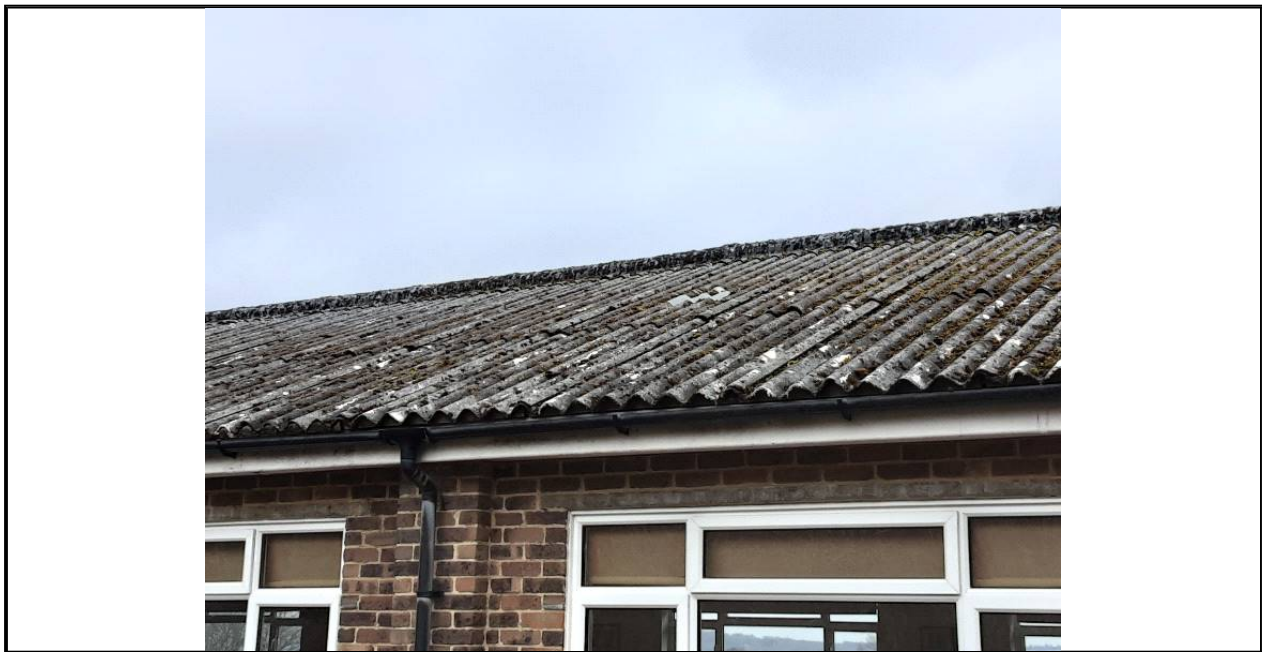
Sample No:	SH002795
Item No:	11
Survey Date:	24/02/23
Building:	Hadlow Down Village Hall
Floor:	External
Room No:	External elements
Position:	Corrugated Roof Sheets - Cement
Extent:	243m ²
Substrate:	Bolted, Metal
Material:	(1) Asbestos Cement
Accessibility:	(0) Usually inaccessible or unlikely to be disturbed
Asbestos Type:	Chrysotile
Risk Category:	Very Low
Recommended Action:	Low risk ACM (bound in matrix) remove, repair or encapsulate under controlled conditions. Work on this material does not require a license. Work on this material may be notifiable to the appropriate enforcing authority. Disposal of asbestos waste by a licensed contractor only. All work must conform to the 'Control of Asbestos Regulations 2012'.

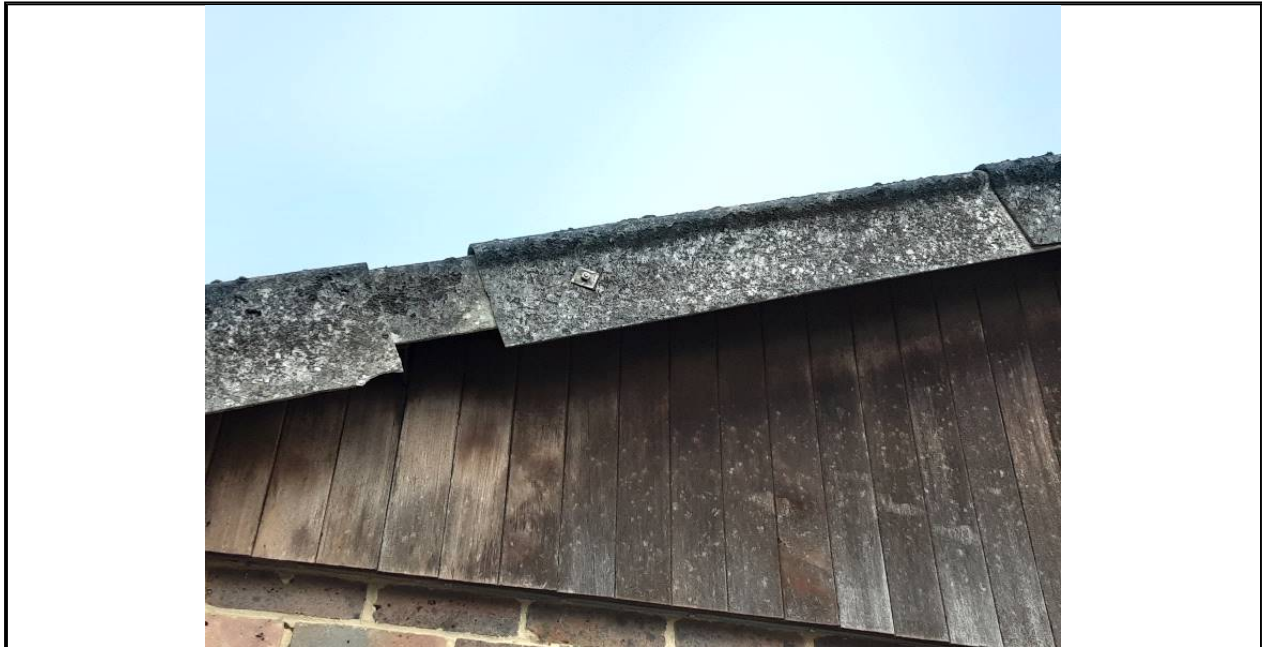
Sample No:	SH002796
Item No:	12
Survey Date:	24/02/23
Building:	Hadlow Down Village Hall
Floor:	External
Room No:	External elements
Position:	Barge board - Cement
Extent:	20lm
Substrate:	Bolted, Metal
Material:	(1) Asbestos Cement
Accessibility:	(0) Usually inaccessible or unlikely to be disturbed
Asbestos Type:	Chrysotile
Risk Category:	Very Low
Recommended Action:	Low risk ACM (bound in matrix) remove, repair or encapsulate under controlled conditions. Work on this material does not require a license. Work on this material may be notifiable to the appropriate enforcing authority. Disposal of asbestos waste by a licensed contractor only. All work must conform to the 'Control of Asbestos Regulations 2012'.

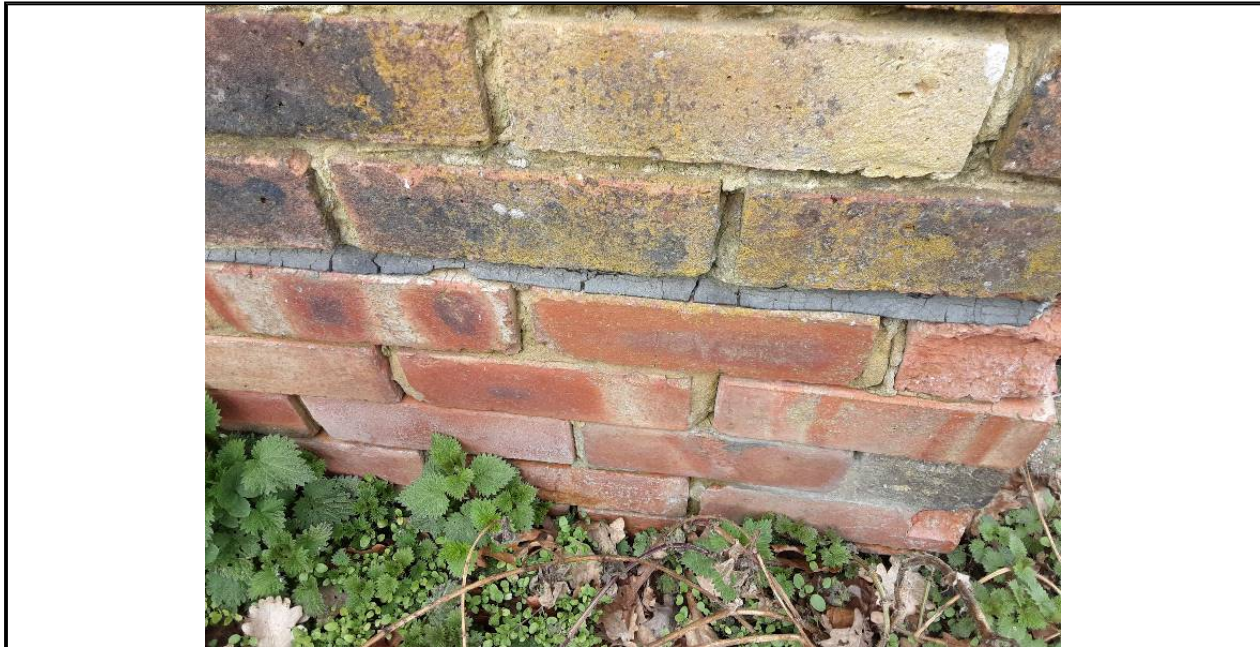
Sample No:	SH002797
Item No:	13
Survey Date:	24/02/23
Building:	Hadlow Down Village Hall
Floor:	External
Room No:	External elements
Position:	Damp Proof Course - Bitumen Products
Extent:	72lm
Substrate:	Bonded, Brick
Material:	(1) Well Bound Material
Accessibility:	(0) Usually inaccessible or unlikely to be disturbed
Asbestos Type:	Chrysotile
Risk Category:	Very Low
Recommended Action:	Low risk ACM (Bound in matrix). Where appropriate label with warning signs. Undertake routine inspections for damage and deterioration. Work on this material does not require a license. Work on this material may be notifiable to the appropriate enforcing authority. Disposal of asbestos waste by a licensed contractor only. All work must conform to the 'Control of Asbestos Regulations 2012'.

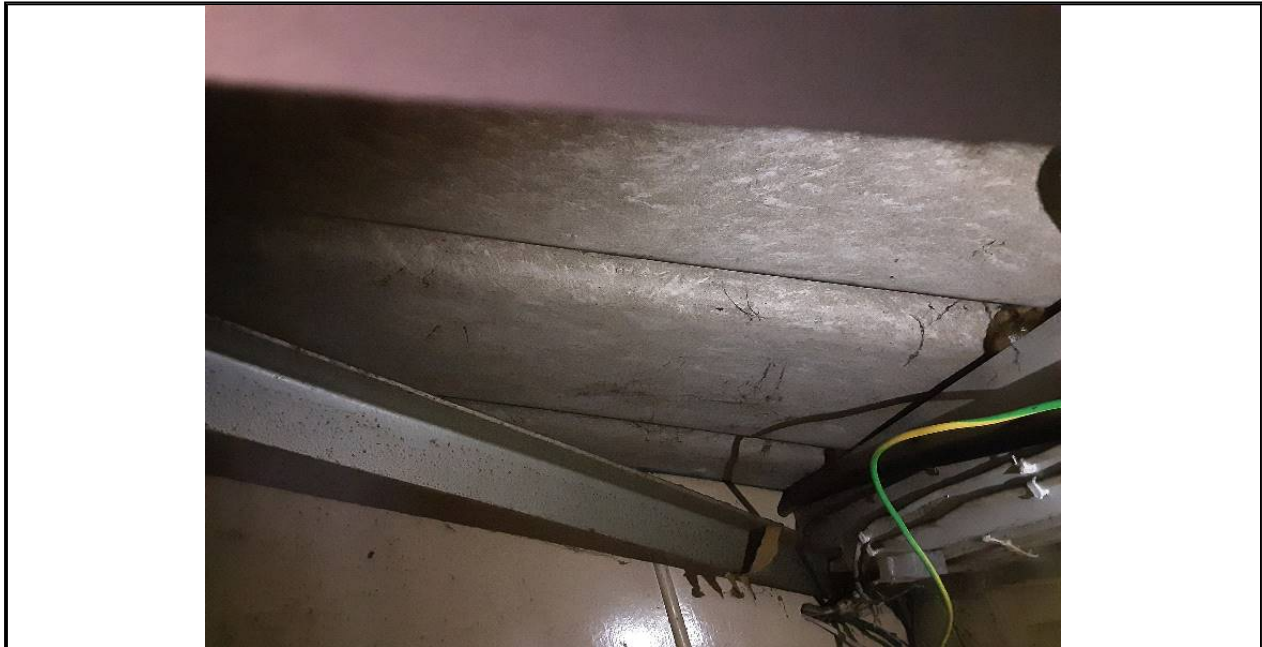
1	SH002794	Hadlow Down Village Hall	Ground Floor	1	Main hall and stage	Above suspended ceiling - Cement	180m ²	Bolted, Metal	(1) Asbestos Cement	Good Condition	1	Chrysotile	(0) Usually inaccessible or unlikely to be disturbed	8	Very Low
Main hall and stage: Cement sheets above suspended metal grid ceiling framework with modern mmmf ceiling tiles, painted block walls, hardboard wall panels, upvc window attached to upvc frames, timber window sills, wall mounted modern electrical storage heaters, timber and upvc doors attached to timber and upvc frames, sanded and varnished floor boards on solid concrete floor, modern vinyl on stage area															
2	As SH002794	Hadlow Down Village Hall	Ground Floor	2	Committee room	Above suspended ceiling - Cement	27m ²	Bolted, Metal	(1) Asbestos Cement	Good Condition	1	Chrysotile	(0) Usually inaccessible or unlikely to be disturbed	8	Very Low
Committee room: Cement sheets above plasterboard ceiling with a smooth painted finish, painted block walls, upvc window attached to upvc frames, timber window sills, wall mounted modern electrical storage heaters, timber and upvc doors attached to timber and upvc frames, sanded and varnished floor boards on solid concrete floor, modern carpet on solid concrete floor

Sample No:	SH002794
Item No:	1
Survey Date:	24/02/23
Building:	Hadlow Down Village Hall
Floor:	Ground Floor
Room No:	Main hall and stage
Position:	Above suspended ceiling - Cement
Extent:	180m ²
Substrate:	Bolted, Metal
Material:	(1) Asbestos Cement
Accessibility:	(0) Usually inaccessible or unlikely to be disturbed
Asbestos Type:	Chrysotile
Risk Category:	Very Low
Recommended Action:	Low risk ACM (bound in matrix) remove, repair or encapsulate under controlled conditions. Work on this material does not require a license. Work on this material may be notifiable to the appropriate enforcing authority. Disposal of asbestos waste by a licensed contractor only. All work must conform to the 'Control of Asbestos Regulations 2012'.

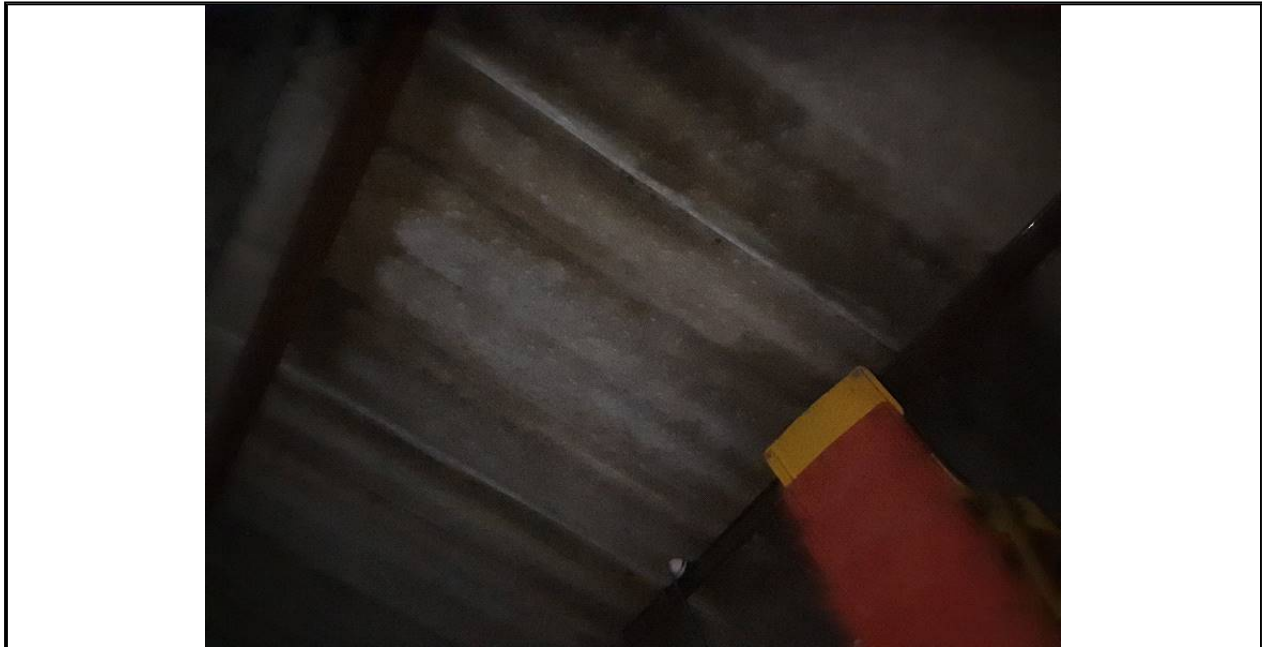
Sample No:	As SH002794
Item No:	2
Survey Date:	24/02/23
Building:	Hadlow Down Village Hall
Floor:	Ground Floor
Room No:	Commitee room
Position:	Above suspended ceiling - Cement
Extent:	27m ²
Substrate:	Bolted, Metal
Material:	(1) Asbestos Cement
Accessibility:	(0) Usually inaccessible or unlikely to be disturbed
Asbestos Type:	Chrysotile
Risk Category:	Very Low
Recommended Action:	Low risk ACM (bound in matrix) remove, repair or encapsulate under controlled conditions. Work on this material does not require a license. Work on this material may be notifiable to the appropriate enforcing authority. Disposal of asbestos waste by a licensed contractor only. All work must conform to the 'Control of Asbestos Regulations 2012'.

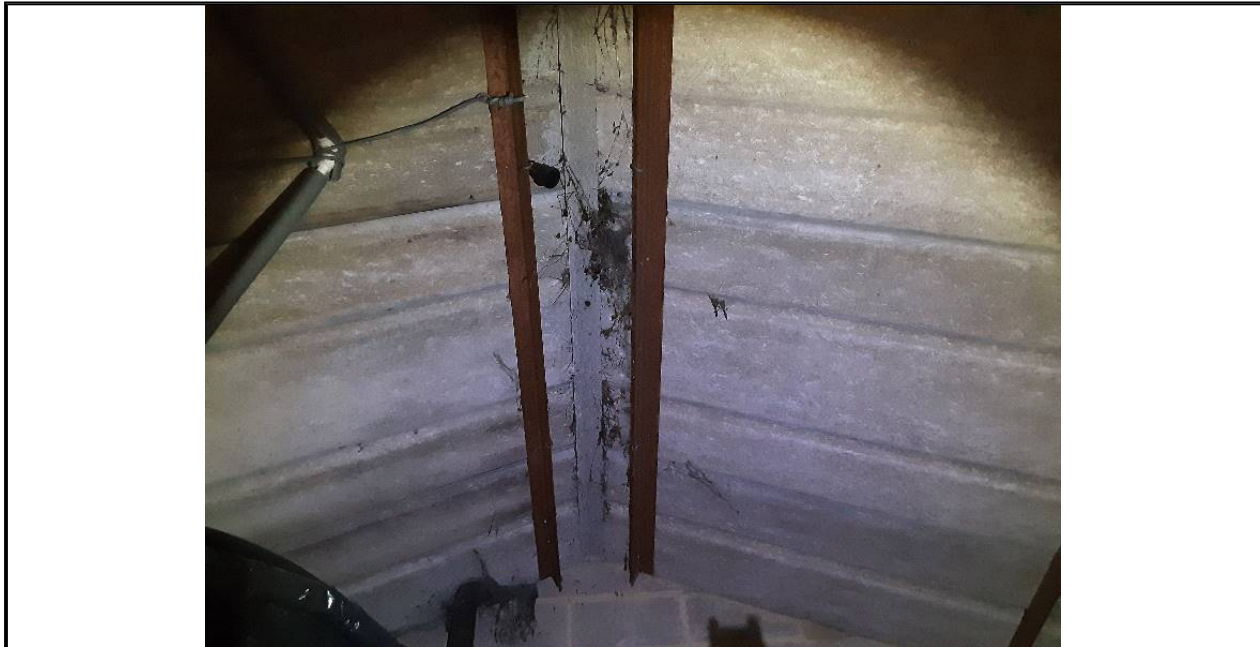
Sample No:	As SH002794
Item No:	3
Survey Date:	24/02/23
Building:	Hadlow Down Village Hall
Floor:	Ground Floor
Room No:	Lobby
Position:	Above suspended ceiling - Cement
Extent:	36m ²
Substrate:	Bolted, Metal
Material:	(1) Asbestos Cement
Accessibility:	(0) Usually inaccessible or unlikely to be disturbed
Asbestos Type:	Chrysotile
Risk Category:	Very Low
Recommended Action:	Low risk ACM (bound in matrix) remove, repair or encapsulate under controlled conditions. Work on this material does not require a license. Work on this material may be notifiable to the appropriate enforcing authority. Disposal of asbestos waste by a licensed contractor only. All work must conform to the 'Control of Asbestos Regulations 2012'.

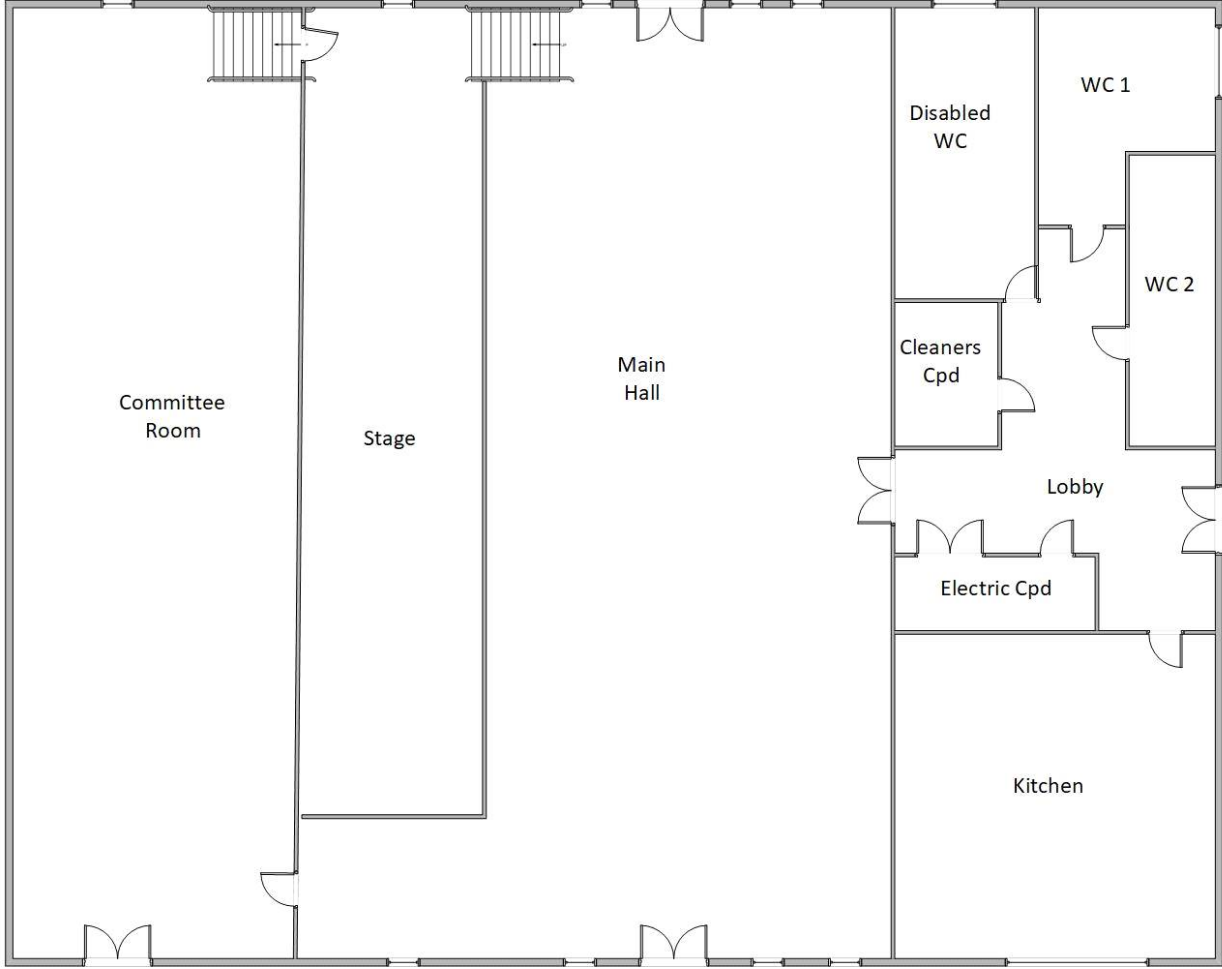
Client: Hadlow Down Village Hall
Site Address: Hadlow Down Village Hall, Hall Lane, Hadlow Down
Position: Ground Floor
Not to Scale

SH002794
Cement
Sheets
Above
Plasterboard
And
Suspended
Ceiling
Throughout
