Management Survey

Site: Hadlow Down Village HALL, Hall Lane, Hadlow Down, TN22 4HQ
UPRN: N/A
Client: Hadlow Down Village Hall
Report No: J024575
Survey Date: 24th February 2023
Report Date: 24th February 2023
Surveyors: Martin Lisher

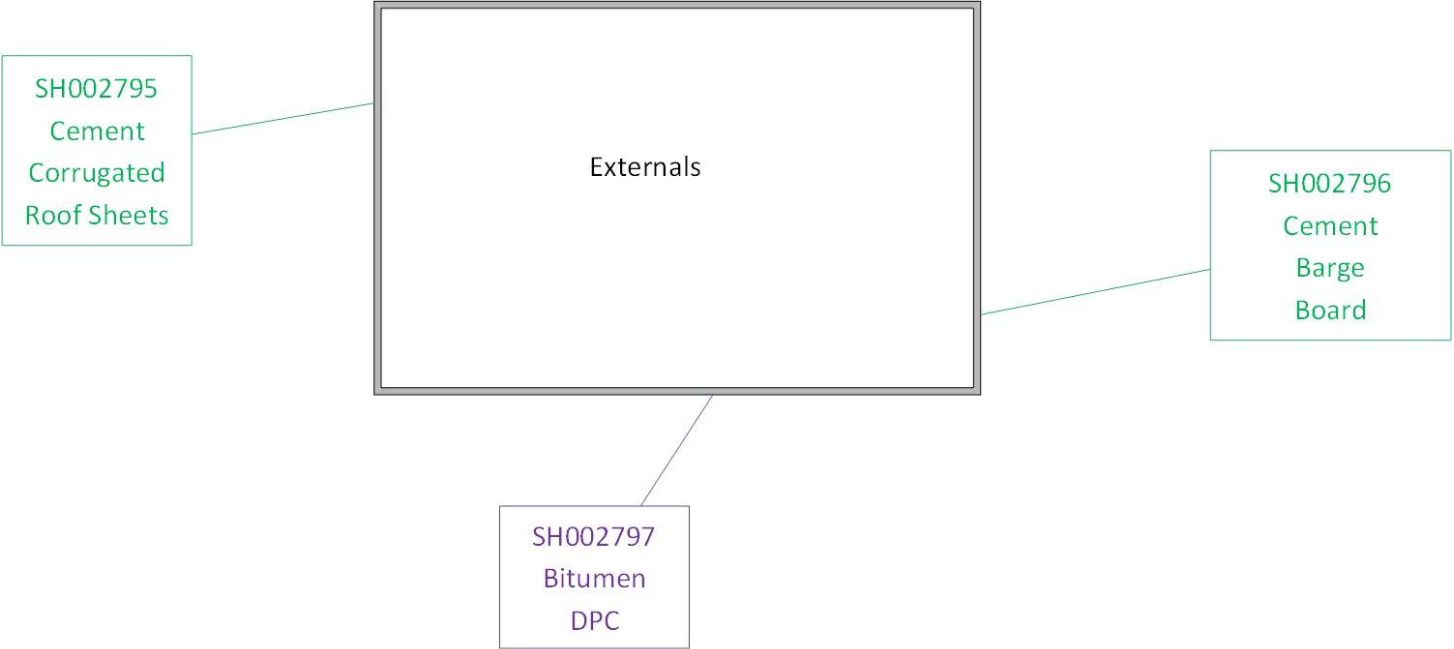
Client: Hadlow Down Village Hall
Site Address: Hadlow Down Village Hall, Hall Lane, Hadlow Down
Position: External
Not to Scale

Sample ID	Building	Floor	Description	Room/Position	Extent (m2)	Fixing	Substrate	Asbestos Type Identified
SH002795	Hadlow Down Village Hall	External	Cement	External elements, Corrugated Roof Sheets	243m ²	Bolted	Metal	Chrysotile
Recommendations					Assessment Scores			Risk Code
					Material	Priority	Total	
Low risk ACM (bound in matrix) remove, repair or encapsulate under controlled conditions. Work on this material does not require a license. Work on this material may be notifiable to the appropriate enforcing authority. Disposal of asbestos waste by a licensed contractor only. All work must conform to the 'Control of Asbestos Regulations 2012'.					5	2	7	Very Low
Reinspection Due		12 months	Actions Taken	N/A	Time Scale			Action Completed Sign & Date

Sample ID	Building	Floor	Description	Room/Position	Extent (m2)	Fixing	Substrate	Asbestos Type Identified
SH002796	Hadlow Down Village Hall	External	Cement	External elements, Barge board	20lm	Bolted	Metal	Chrysotile
Recommendations					Assessment Scores			Risk Code
					Material	Priority	Total	
Low risk ACM (bound in matrix) remove, repair or encapsulate under controlled conditions. Work on this material does not require a license. Work on this material may be notifiable to the appropriate enforcing authority. Disposal of asbestos waste by a licensed contractor only. All work must conform to the 'Control of Asbestos Regulations 2012'.					5	2	7	Very Low
Reinspection Due		12 months	Actions Taken	N/A	Time Scale			Action Completed Sign & Date

Sample ID	Building	Floor	Description	Room/Position	Extent (m2)	Fixing	Substrate	Asbestos Type Identified
SH002797	Hadlow Down Village Hall	External	Bitumen Products	External elements, Damp Proof Course	72lm	Bonded	Brick	Chrysotile
Recommendations					Assessment Scores			Risk Code
					Material	Priority	Total	
Low risk ACM (Bound in matrix). Where appropriate label with warning signs. Undertake routine inspections for damage and deterioration. Work on this material does not require a license. Work on this material may be notifiable to the appropriate enforcing authority. Disposal of asbestos waste by a licensed contractor only. All work must conform to the 'Control of Asbestos Regulations 2012'.					2	2	4	Very Low
Reinspection Due		12 months	Actions Taken	N/A	Time Scale			Action Completed Sign & Date
